Safety Inspection Report

Annual Inspection

The Fairground Mortimer - Play Area

Stratfield Mortimer Parish Council

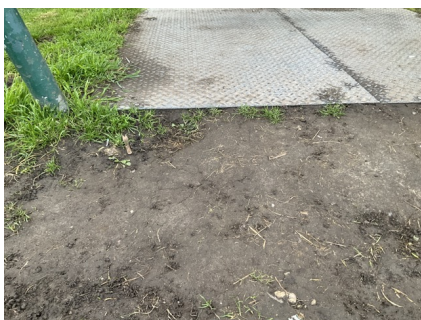
Trip points on the surface.

Projecting foundations.

Make level.

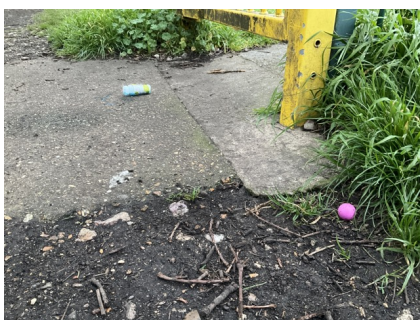
Trip points on the surface.

Make level.

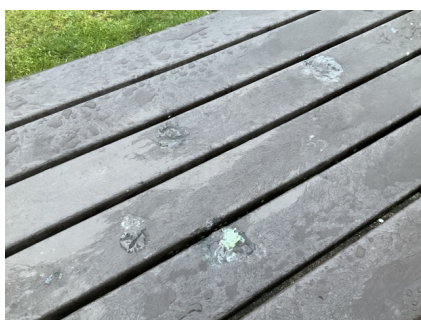
Item is damaged.

Some arson / vandalism.

No reasonably practicable action is identified.

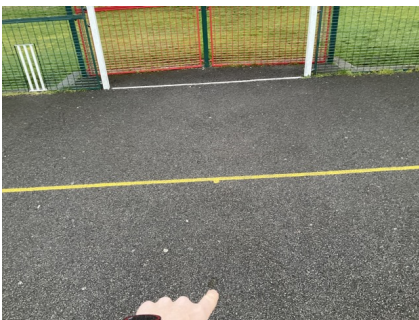
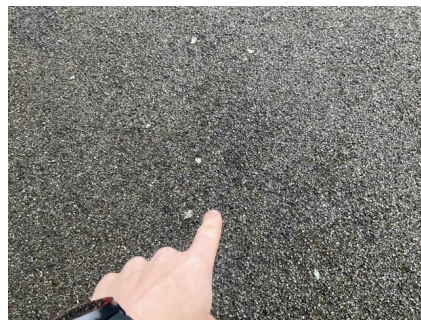
Surface has small holes or dips.

Overall surfacing is fairly good. Around the goal mouth some small holes are appearing. Monitor and early intervention with remedial work advised.

Read the notes for further action.

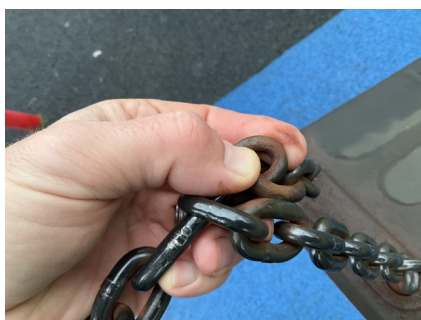
Some chain wear.

Early signs of chain wear. Monitor.

Monitor for further deterioration and replace before 40% wear.

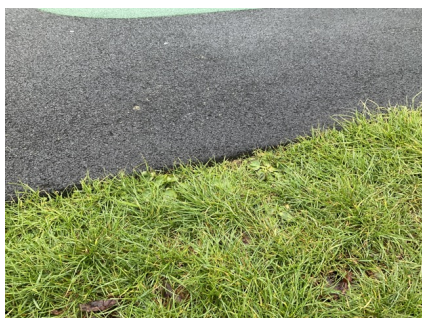
Shrinkage / separation of the surface. This may give a trip hazard.

Allow grass to establish in the gap, as this may prevent the wet pour from shrinking further.

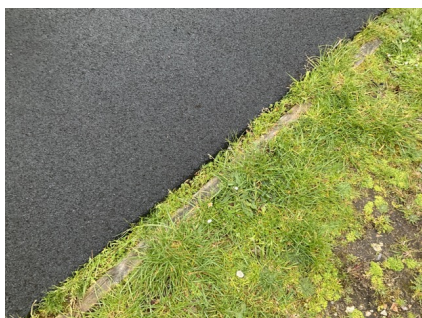
Shrinkage / separation of the surface. This may give a trip hazard.

Allow grass to establish in the gap, as this may prevent the wet pour from shrinking further.

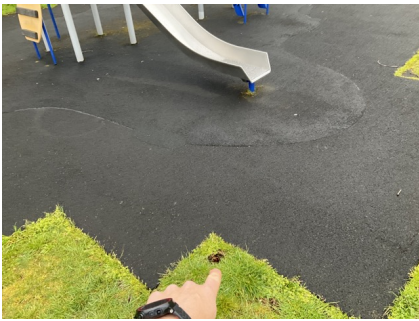
Surface has small holes or dips.

Repair.

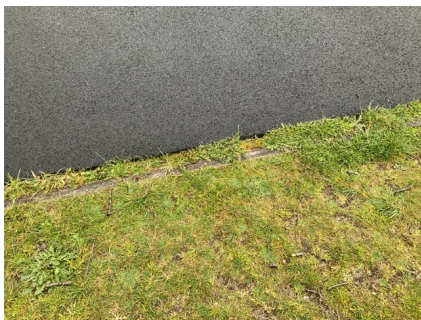
Shrinkage / separation of the surface. This may give a trip hazard.

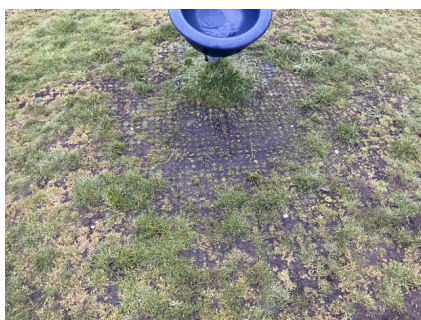
Surface needs repair.

Repair.

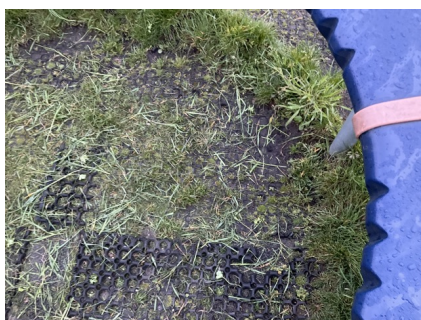
Infill under mats. Surface needs repair, mats separating.

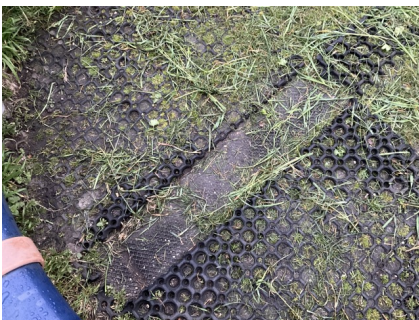
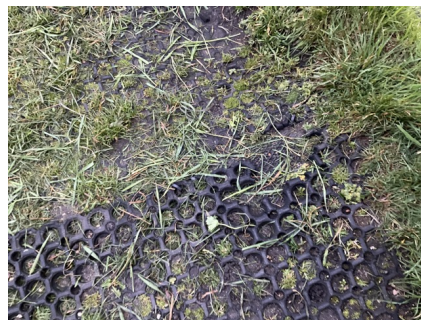
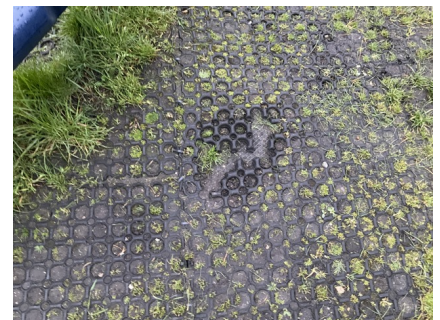
The surface is damaged.

The grass matting has broken up with pieces removed. This compromises the purpose of the surfacing. Repair.

Read the notes for further action., Repair.

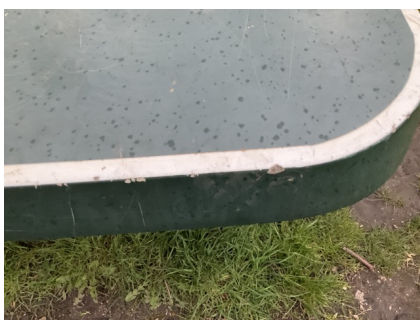
Concrete edges are in poor condition.

Repair.
