# Safety Inspection Report

Annual Inspection

## The Fairground Mortimer - Play Area

23 May 2025

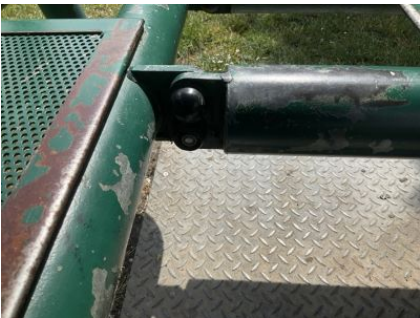
Trip points on the surface.

## Projecting foundations.

Bolt cap damaged.

Replace.

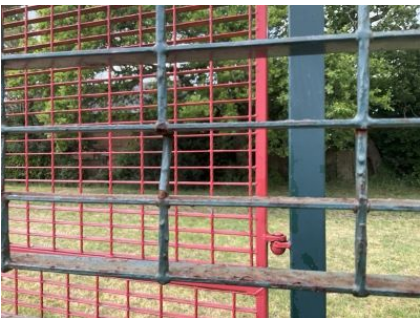
Welds are cracked.

Repair.

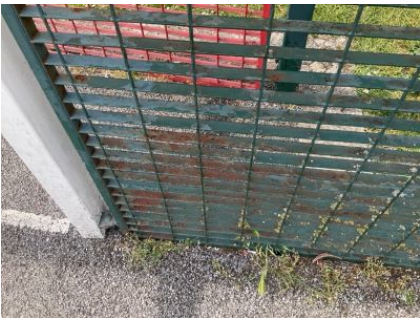
Item has corrosion.

Treat and repair.

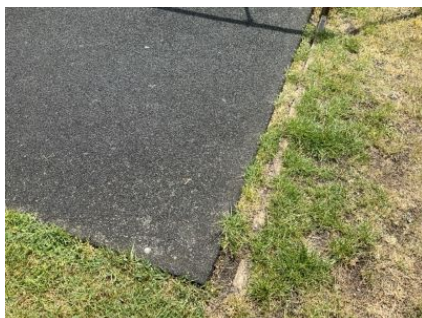
Shrinkage / separation of the surface. This may give a trip hazard.

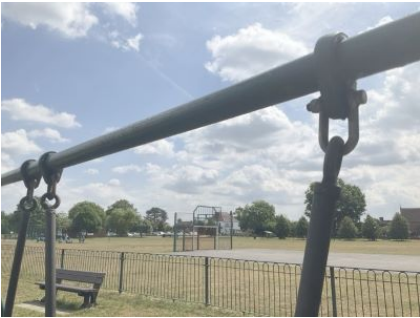
There is wear in the bushes.

Evidence of greasing maintenance etc. though the movement laterally and visually from the side suggests some wear in the bushes. Monitor and schedule replacement.

Remove shackle bolt and check bush and shackle pin wear, replacing as necessary.

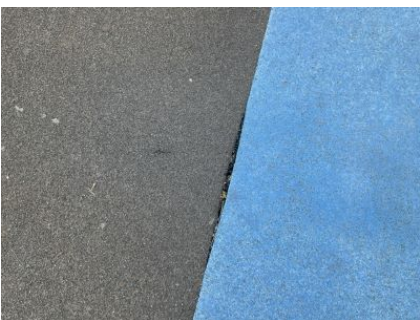
The wet pour surface is cracking.

Repair.

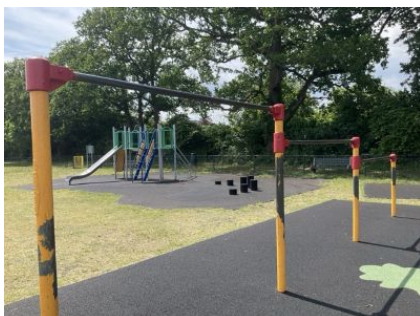
Fixtures loose or missing.

All fixings slightly loose.

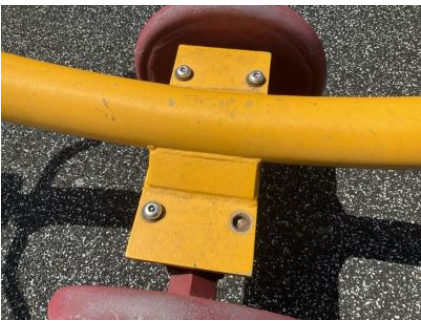
Fixtures loose or missing.

Replace.

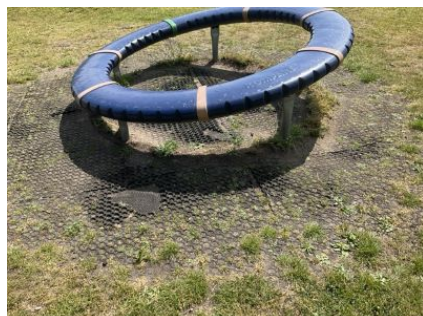
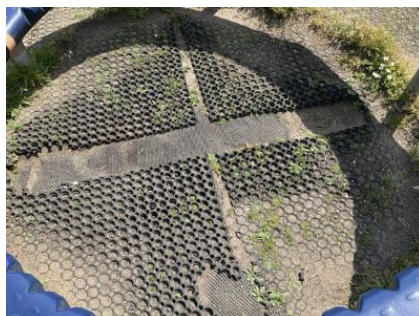
The surface is damaged.

The grass matting has broken up with pieces removed. This compromises the purpose of the surfacing. Repair.

Read the notes for further action., Repair.

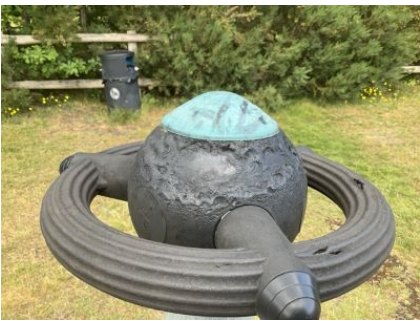
Bolt cap damaged.

Replace.

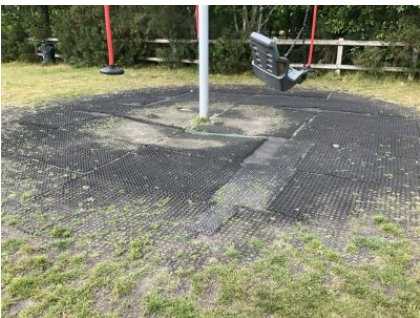
Worn ground areas.

The surface is heavily worn and is unlikely to provide adequate impact attenuation. Consider installing an alternative harder wearing safer surface.

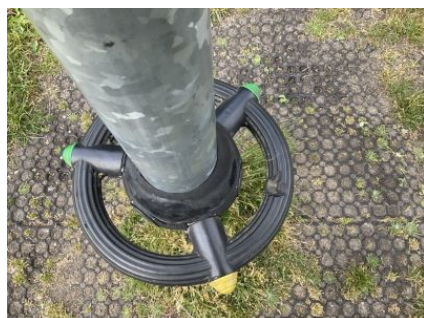
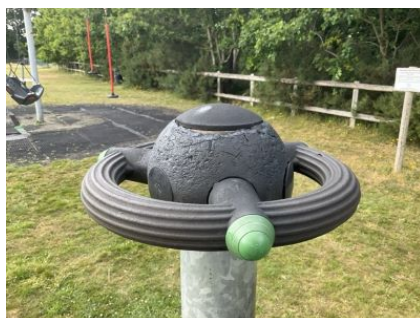
Item is damaged.

Lower foot hold damaged and cap.

Replace.
