# Safety Inspection Report

Annual Inspection

## The Fairground Mortimer - Play Area

Stratfield Mortimer Parish Council

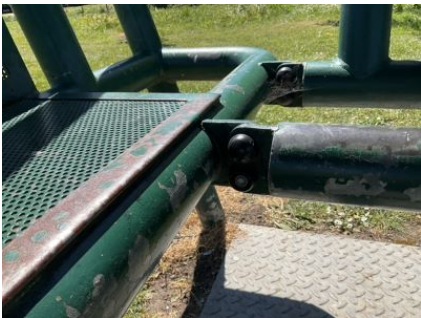
Cap missing.

Replace.

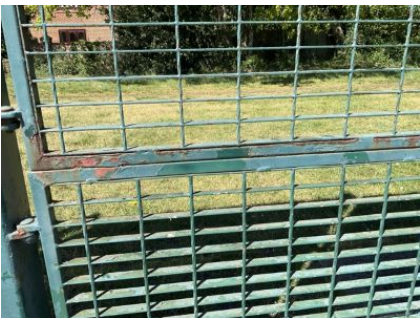
Item has corrosion.

Treat and repair.

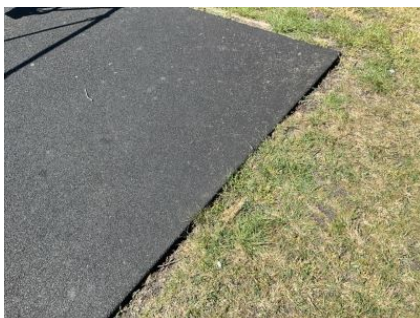
Shrinkage / separation of the surface. This may give a trip hazard.

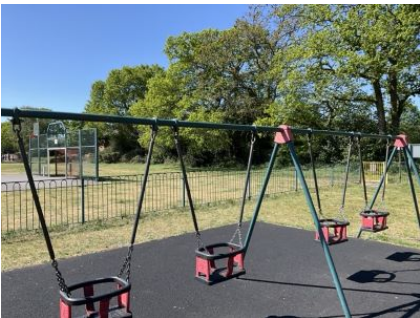
There is wear in the bushes.

Evidence of greasing maintenance etc. though the movement laterally and visually from the side suggests some wear in the bushes. Monitor and schedule replacement.

Remove shackle bolt and check bush and shackle pin wear, replacing as necessary.

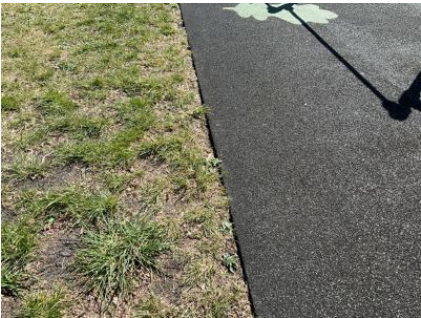
Shrinkage / separation of the surface. This may give a trip hazard.

Edges lifting.

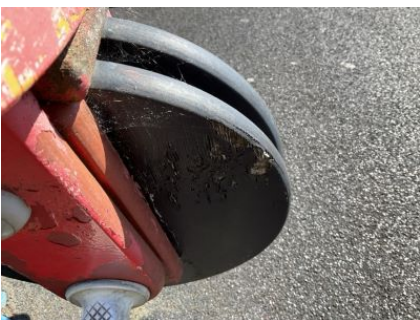
Laminate damaged.

Rub down and treat damaged edges.

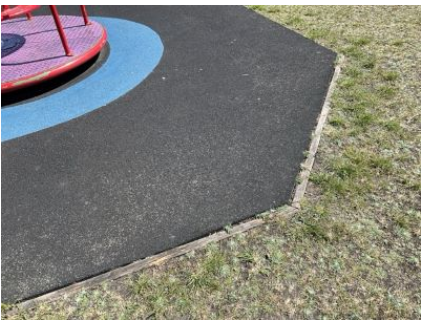
Shrinkage / separation of the surface. This may give a trip hazard.

Repair.

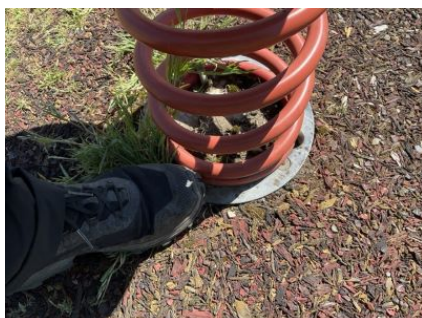
Bolt(s) loose.

Base bolts are loose.

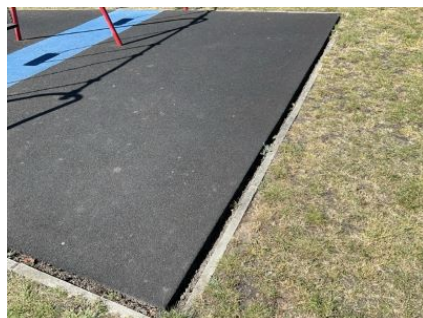
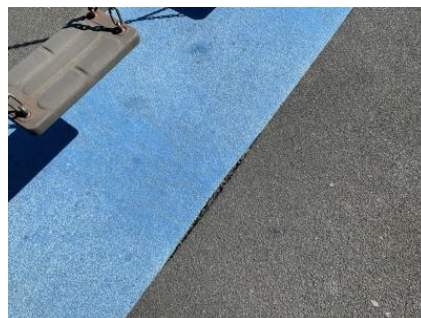
Shrinkage / separation of the surface. This may give a trip hazard.

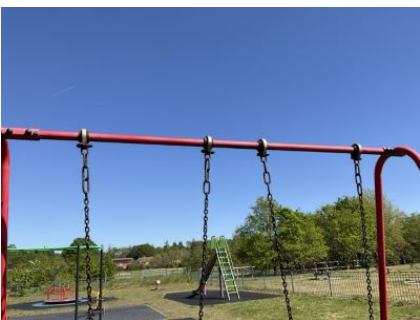
There is wear in the bushes.

Remove shackle bolt and check bush and shackle pin wear, replacing as necessary.

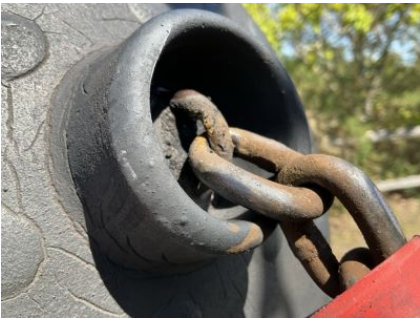
There is considerable wear to the chains.

Replace wearing chains.

Replace the worn chains or links.

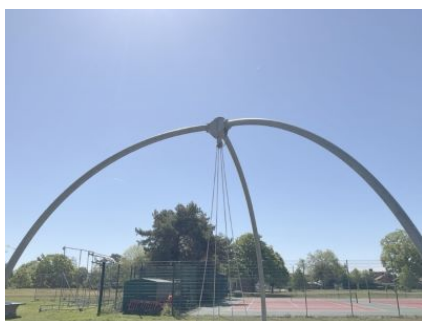
The top of the chains and the supporting component have not been inspected.

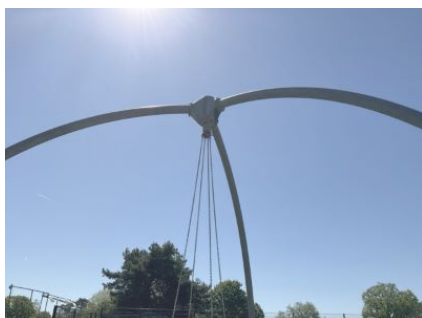
The top of the chains and the supporting component have not been inspected as they are above 3m in height.

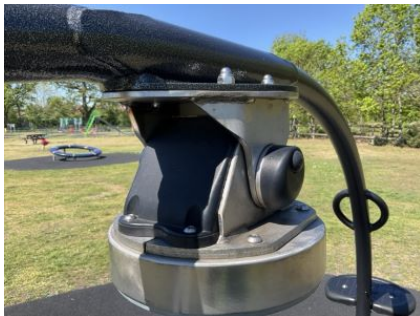
Appears to be some wear to inner parts causing some side to side movement. Investigate further.
