Safety Inspection Report

Annual Inspection

The Fairground Mortimer - Play Area

Stratfield Mortimer Parish Council

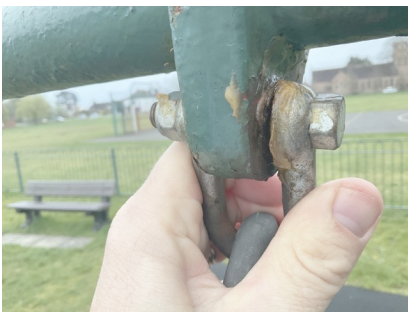
There is wear in the bushes.

Evidence of greasing maintenance etc. though the movement laterally and visually from the side suggests some wear in the bushes. Monitor and schedule replacement.

Remove shackle bolt and check bush and shackle pin wear, replacing as necessary.

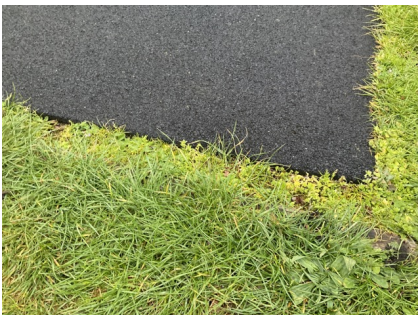
Shrinkage / separation of the surface. This may give a trip hazard.

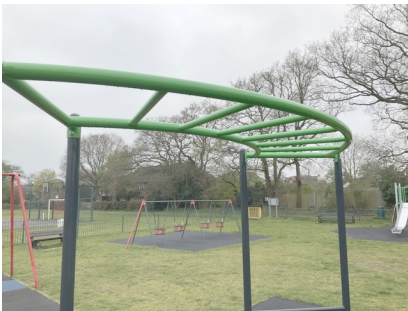
Shrinkage / separation of the surface. This may give a trip hazard.

The protective surface under all bars and rings must be kept in good condition.

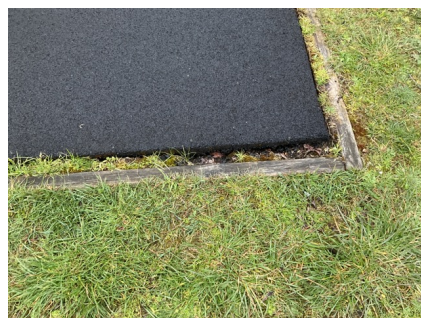
Shrinkage / separation of the surface. This may give a trip hazard.

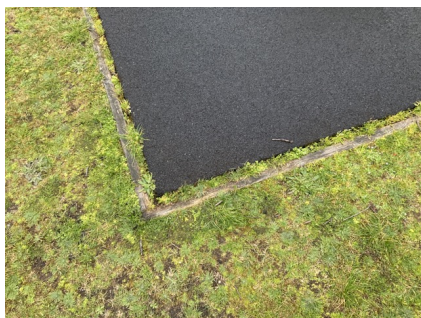
Shrinkage / separation of the surface. This may give a trip hazard.

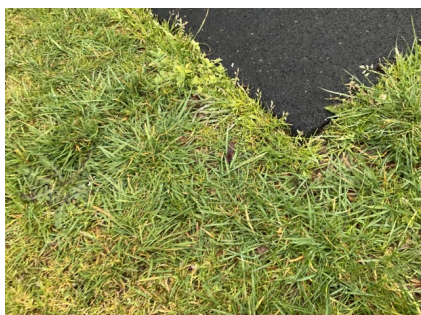
Shrinkage / separation of the surface. This may give a trip hazard.

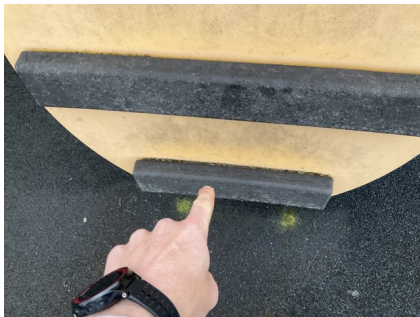
Item is cracked.

Bottom step. Monitor and repair / replace as necessary.

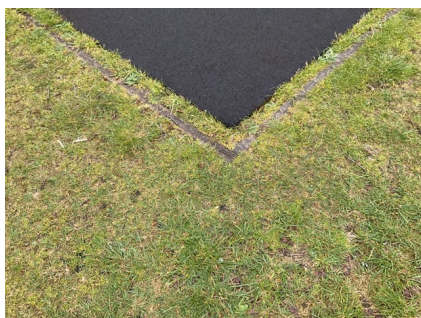
Shrinkage / separation of the surface. This may give a trip hazard.

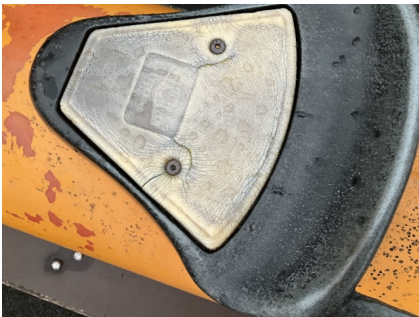
Item is cracked.

Monitor for sharp edges, replace if necessary.

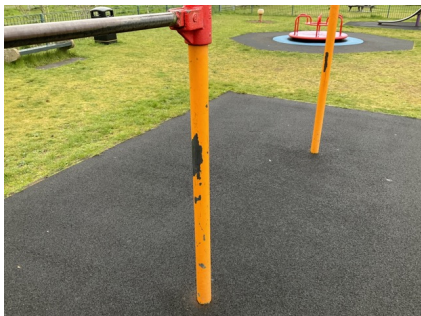
Paintwork is in poor condition.

De-scale back to good base material and coat with lead free paint, using appropriate precautions. Repairs may be necessary where corrosion is severe.

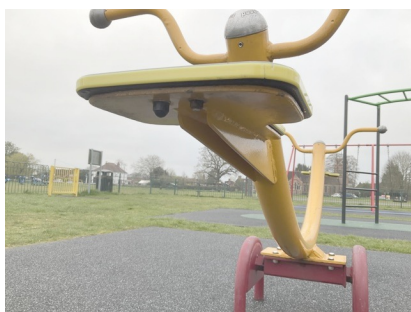
Cap missing.

Replace.

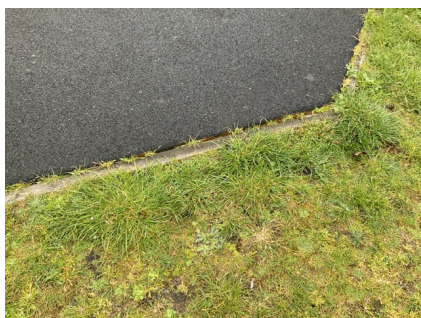
Shrinkage / separation of the surface. This may give a trip hazard.

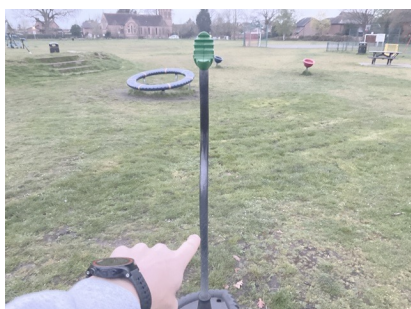
Fixings are loose or missing.

The pole is becoming loose in the base housing. Investigate and secure.

Read the notes for further action., Secure or replace fixings to ensure structural integrity is maintained.

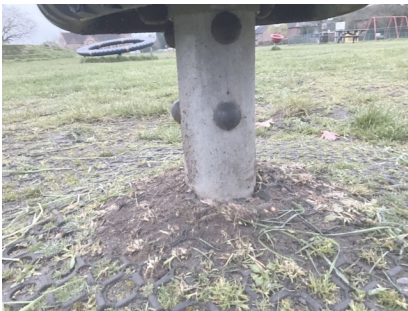
There is wear in the bearings.

Monitor and replace when necessary.

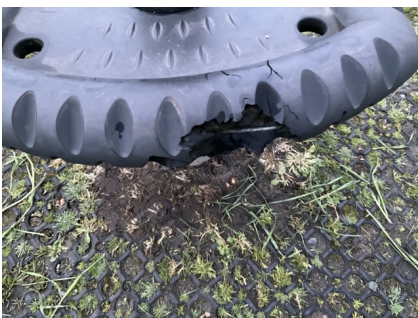
Item is damaged.

Rubber platform damaged. Metal ridge showing. Cover over.

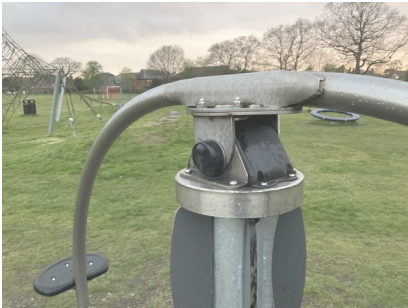
The mechanism is beginning to show externally detectable signs of wear.

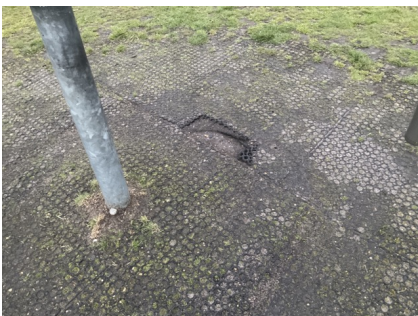
Worn ground areas.

The worn / uneven surface may not provide adequate impact attenuation.

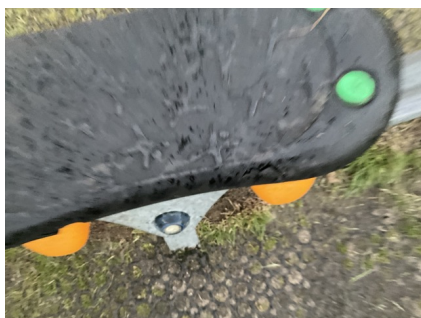
Item is damaged.

Repair.

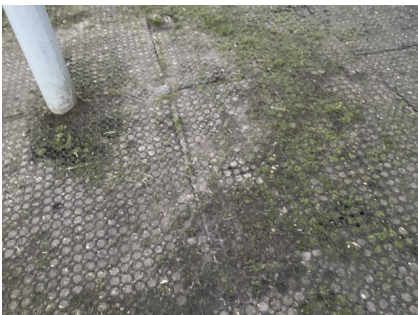
Worn ground areas.

The surface is heavily worn and is unlikely to provide adequate impact attenuation. Consider installing an alternative surface.

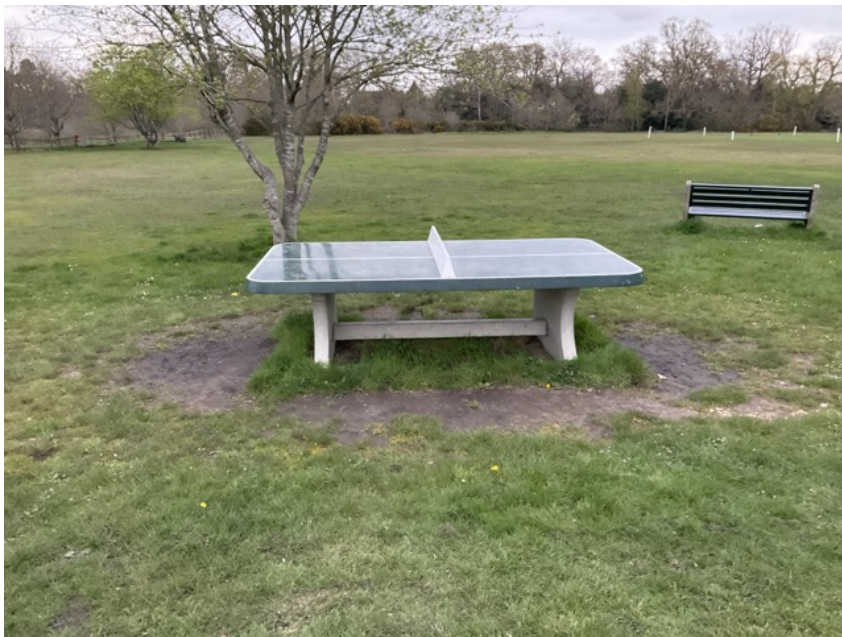
Table Tennis Table

Concrete edges are in poor condition.

Repair.
