# Safety Inspection Report

Annual Inspection

## The Fairground Mortimer - Play Area

23 May 2025

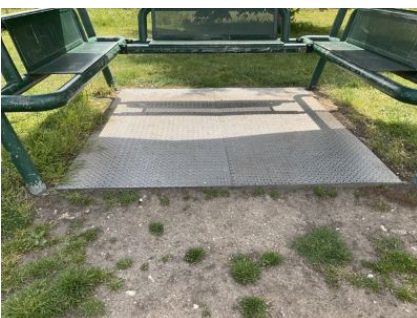
Trip points on the surface.

## Projecting foundations.

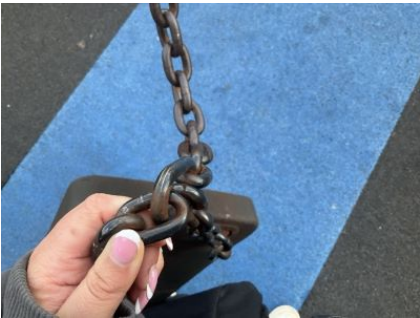
Some chain wear.

Early signs of chain wear. Monitor.

Monitor for further deterioration and replace before 40% wear.

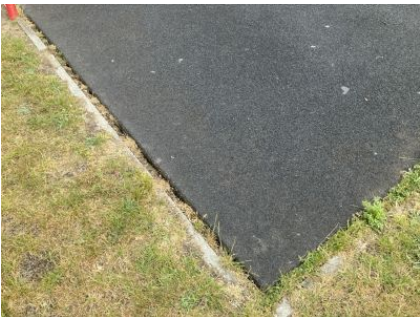
Shrinkage / separation of the surface. This may give a trip hazard.

Monitor for the development of a trip hazard, make repairs if necessary.

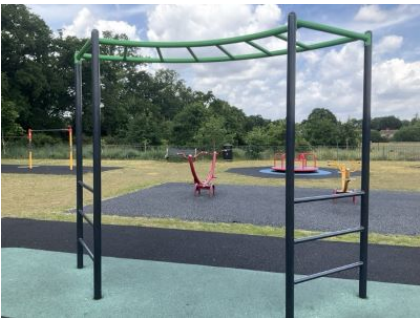
Overhead ladders and rings provide significant play value and benefits to children, and with it the risk of falling. Ensuring the surface remains in good condition will help to keep the correct balance between benefits and risk.

The protective surface under all bars and rings must be kept in good condition.

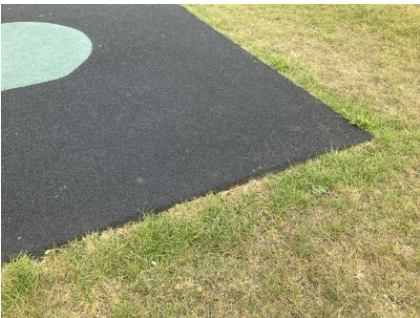
Shrinkage / separation of the surface. This may give a trip hazard.

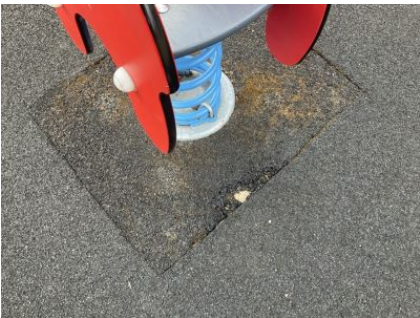
Surface needs repair.

Repair.

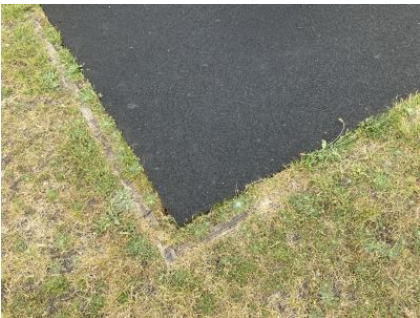
Shrinkage / separation of the surface. This may give a trip hazard.

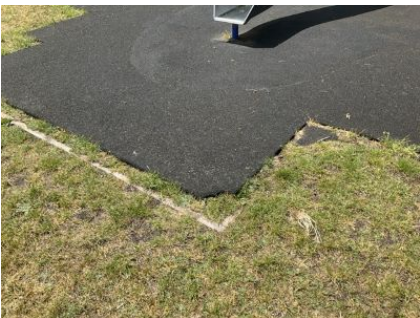
Corners lifting. Make level.

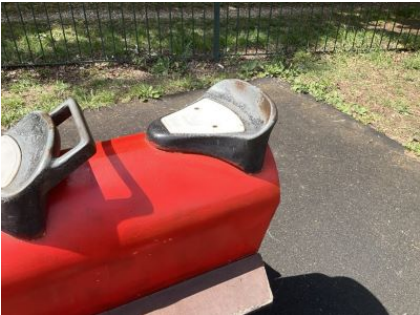
Fixtures loose or missing.

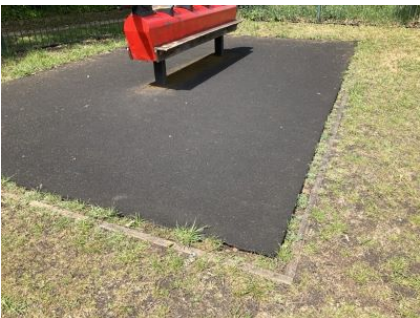
Shrinkage / separation of the surface. This may give a trip hazard.

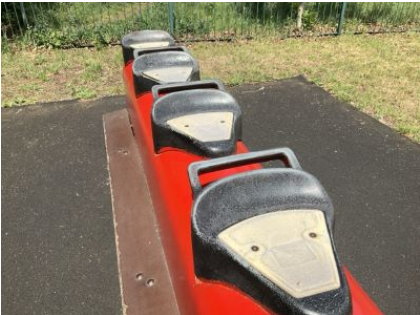
Item is cracked.

Monitor for sharp edges, replace if necessary.

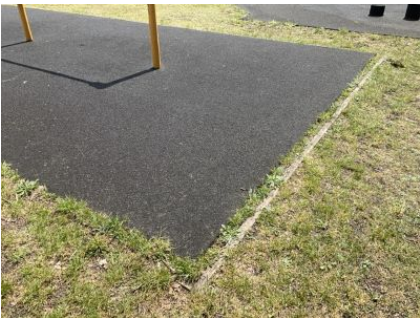
Shrinkage / separation of the surface. This may give a trip hazard.

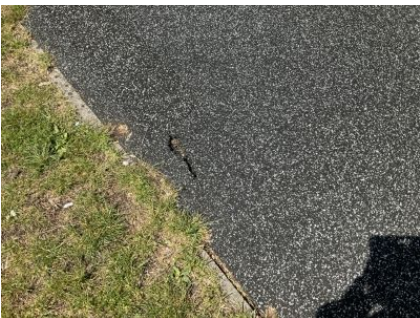
Surface needs repair.

Repair.

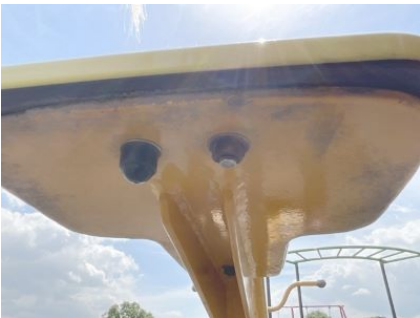
Cap missing.

Replace.

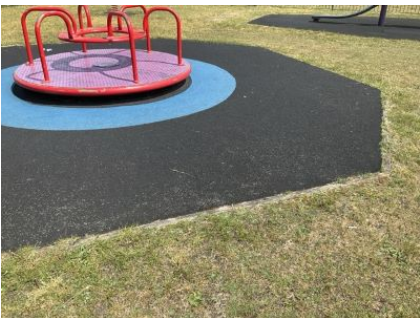
Shrinkage / separation of the surface. This may give a trip hazard.

Repair.

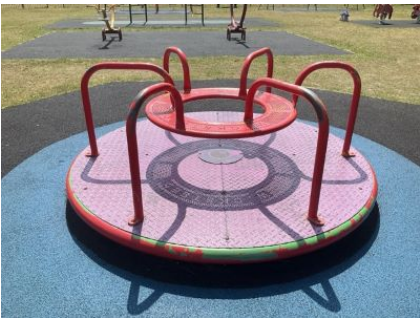
There is wear in the bearings.

Monitor and replace when necessary.

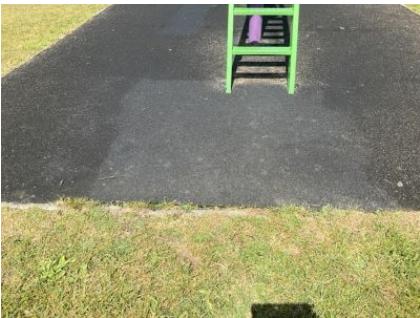
Shrinkage / separation of the surface. This may give a trip hazard.

Repair.

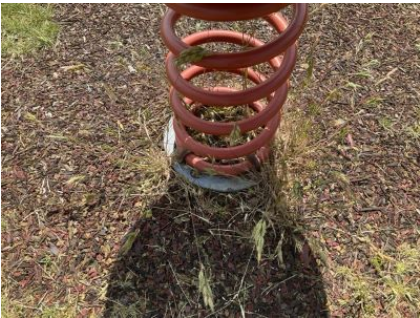
Bolt(s) loose.

Base bolts slightly loose.

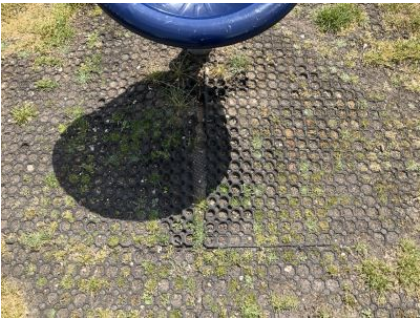
Surface needs repair.

Repair.

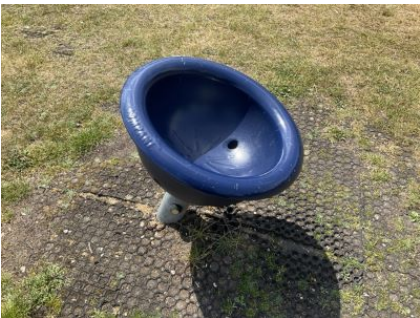
There is wear in the bearings.

Monitor and replace when necessary.

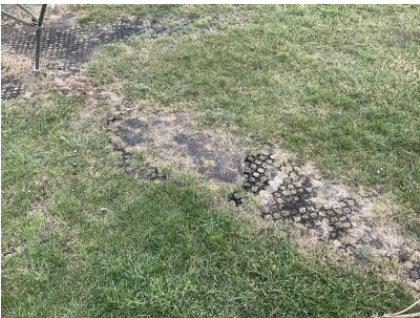
Surface needs repair.

Repair.

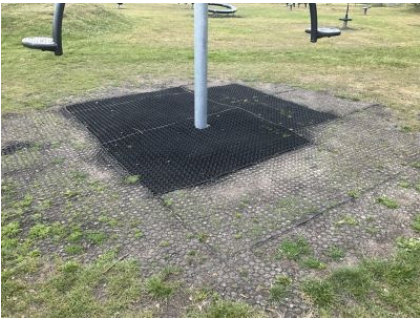
The worn/uneven surface may not provide adequate impact attenuation.

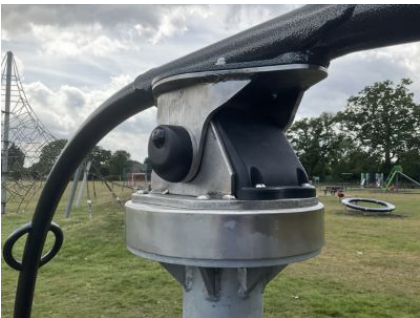
Fixtures loose or missing.

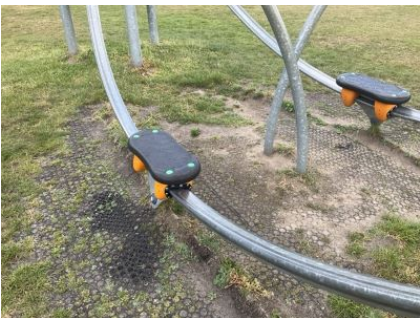
The bearings are worn.

Replace the worn bearings.

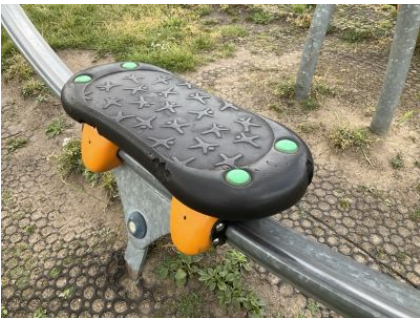
Item is damaged.

Repair.

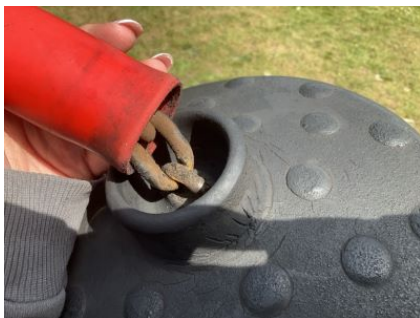
There is considerable wear to the chains.

Replace the worn chains or links.

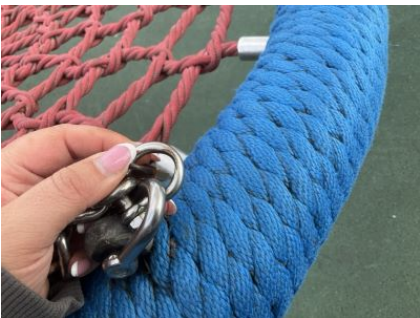
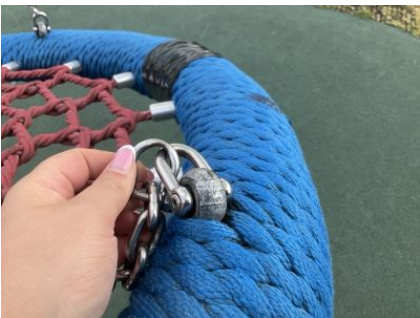
There is considerable wear to the chains.

Replace the worn parts.

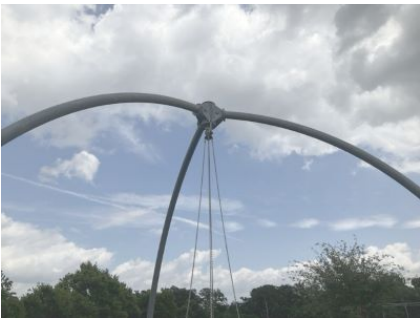
The top of the chains and the supporting component have not been inspected.

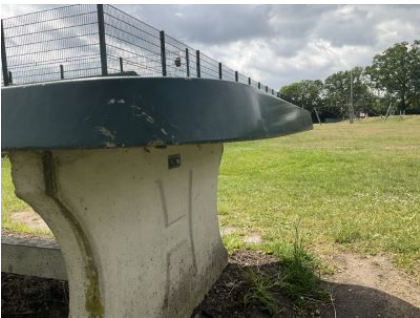
Concrete edges are in poor condition.

Repair.
