# Safety Inspection Report

Annual Inspection

## The Fairground Mortimer - Play Area

Stratfield Mortimer Parish Council

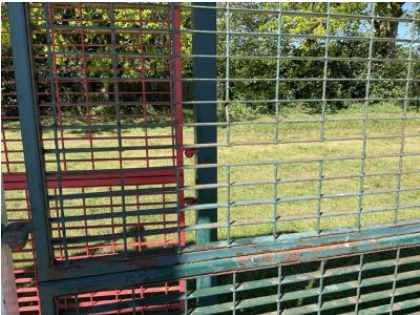
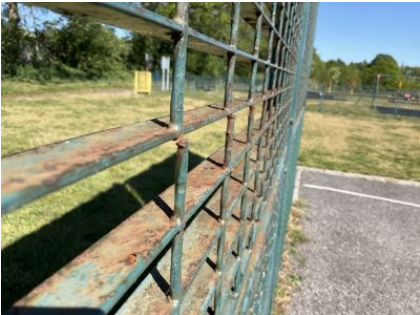
Item has corrosion.

Treat and repair.

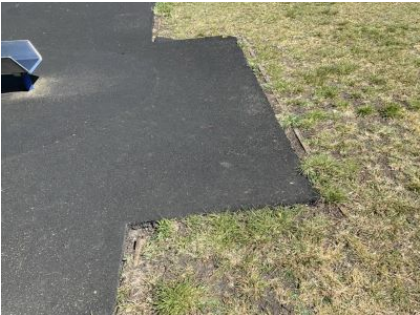
Shrinkage / separation of the surface. This may give a trip hazard.

Corners lifting. Make level.

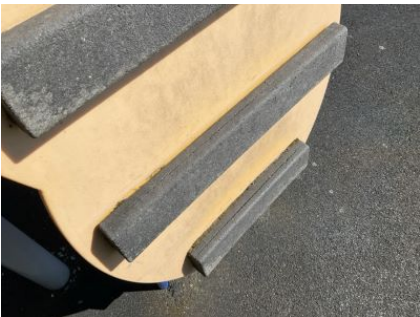
Item is cracked.

Steps. Monitor and repair/replace as necessary.

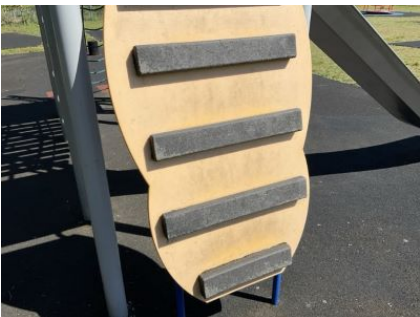
Fixtures loose or missing.

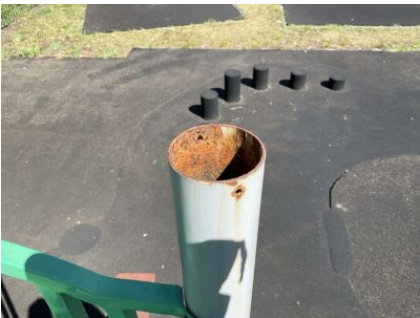
Cap missing.

Caps x 3. Retaining water and corrosion present. Drain, check for damage and replace missing caps.

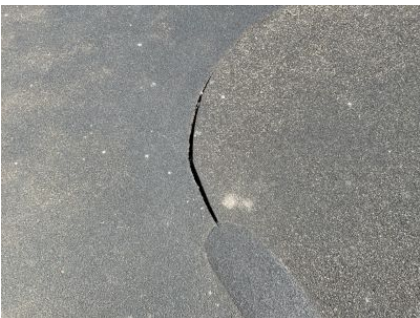
Shrinkage / separation of the surface. This may give a trip hazard.

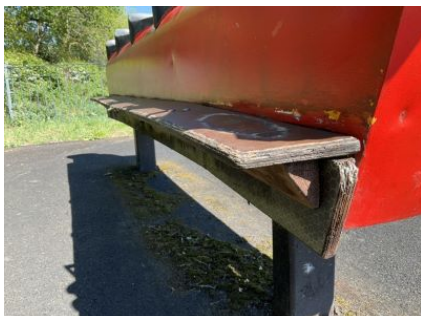
Repair sides as they are loose, broken and rough.

Repair.

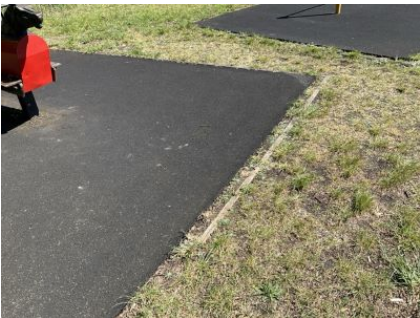
Shrinkage / separation of the surface. This may give a trip hazard.

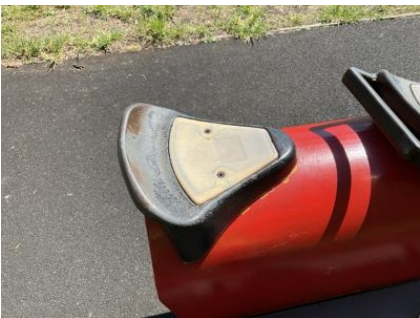
Fixtures loose or missing.

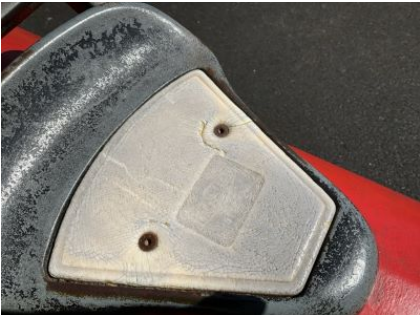
Item is cracked.

Monitor for sharp edges, replace if necessary.

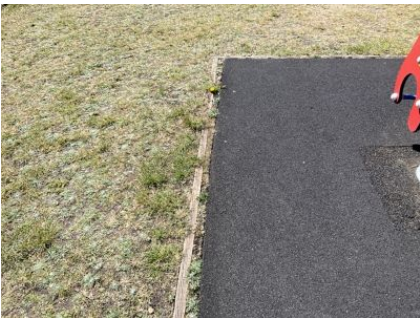
Surface needs repair.

Repair.

Repair hole.

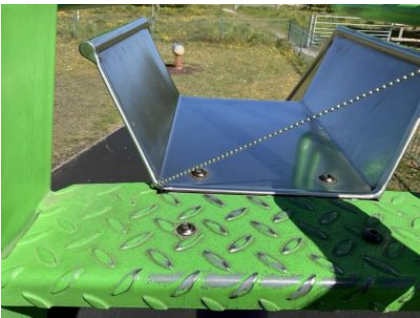
Surface needs repair.

Cracking and separating.

Repair.

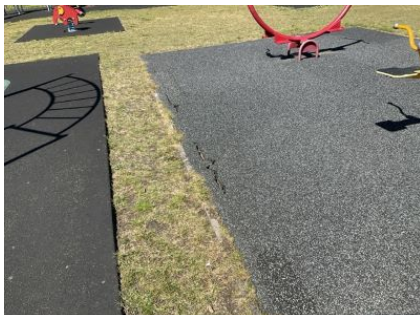
Surface needs repair.

Cracking and separating.

## Repair.

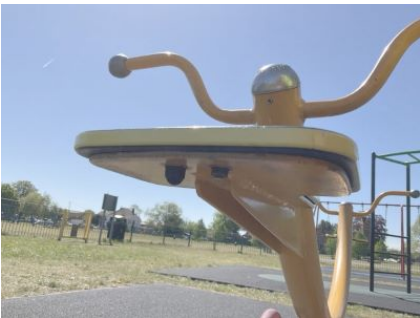
Cap missing.

Replace.

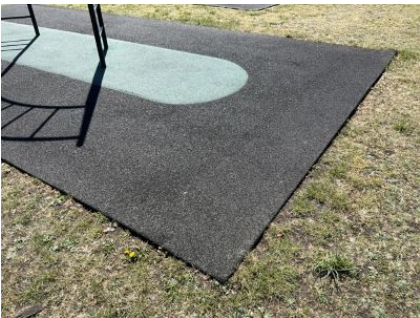
Shrinkage / separation of the surface. This may give a trip hazard.

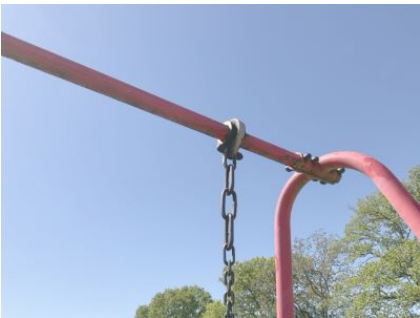
There is wear in the bushes.

Remove shackle bolt and check bush and shackle pin wear, replacing as necessary.

Free off and check for damage.

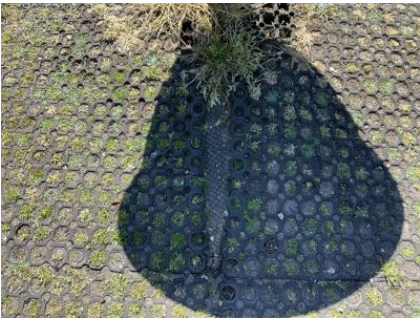
Surface needs repair.

Repair.

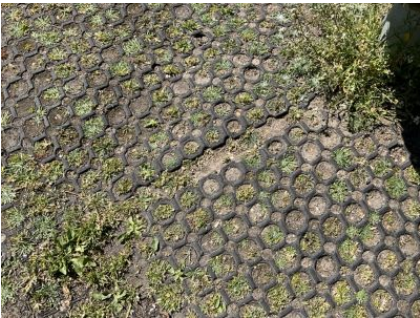
Surface needs repair.

Repair.

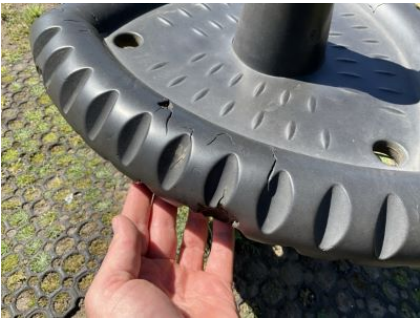
Small damage to platform.

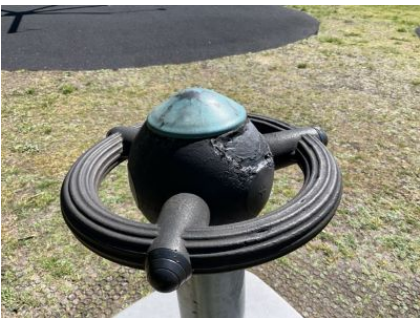
Bolt cap damaged.

Replace.

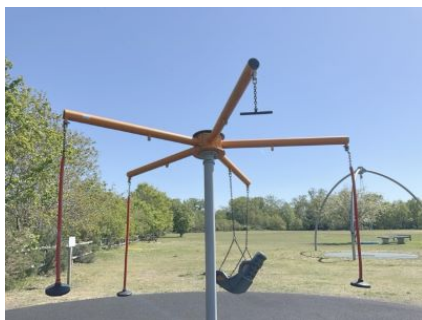
There is considerable wear to the chains.

Replace the worn chains or links.

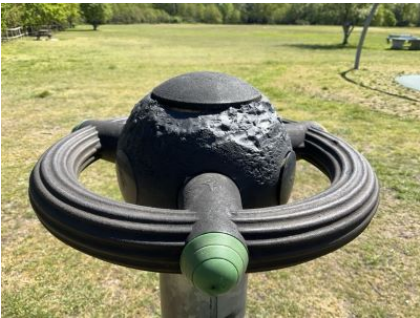
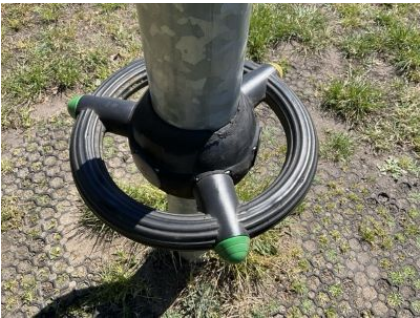
Item is damaged.

Lower foot hold damaged and cap.

Replace.

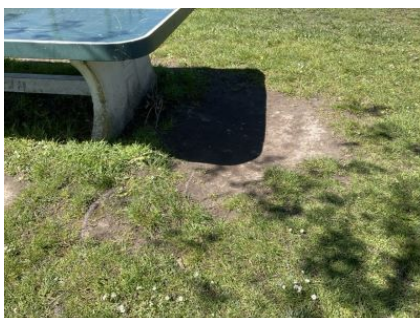
Worn ground areas.

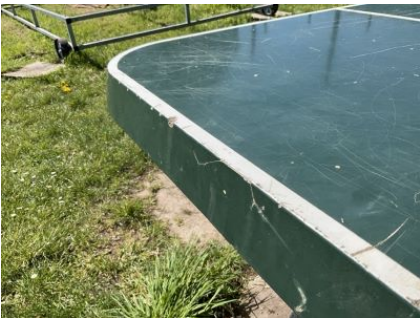
Concrete edges are in poor condition.

Repair.
